The Cause of Cracking in Post-Tensioned Concrete Box Girder Bridges and Retrofit Procedures

Walter Podolny, Jr.
Bridge Division
Office of Engineering
Federal Highway Administration
Washington, D.C.

This paper presents documentation of problems that have led to cracking in post-tensioned concrete box girder bridges in Europe as well as in the United States. It discusses cracking resulting from inadequate flexural and shear capacity, thermal stress cracking, and cracking resulting from tendon curvature and tendon misalignment. Also discussed are possible retrofit measures.

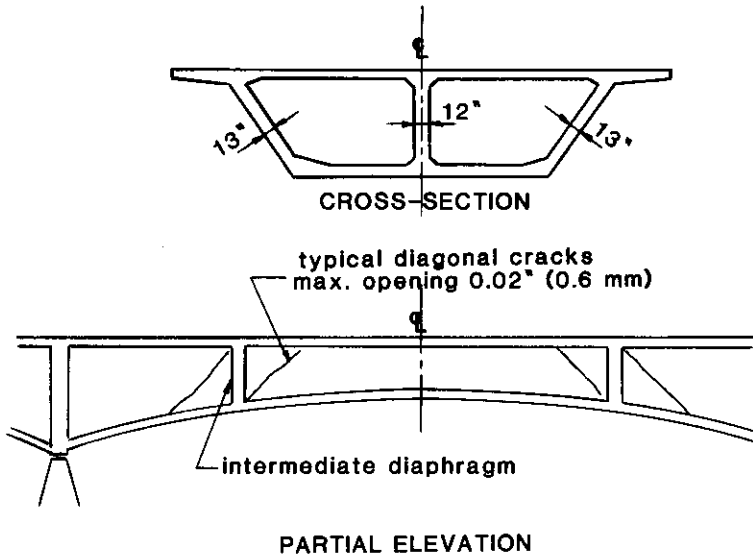
Fig. 7. Web cracking of center web.

vertically curved tendons in the bottom flange. Vertical prestress was applied in the webs to control shear stresses. Diagonal cracking was observed in the center web, only near the intermediate diaphragms, with a maximum crack opening of 0.02 in. (0.6 mm). In addition there was cracking in the bottom flange.

A complete investigation of the problems encountered revealed that cracking was the result of the superposition of several adverse effects, any of which might have been harmless if considered separately:

1. The computation of shear stresses failed to take into account the adverse effect (usually neglected) of the vertical component of continuity prestress in the bottom flange of a girder with variable depth. The curvature of continuity tendons distributed in the bottom flange is such that a downward reaction is produced at the webs that is additive to the shear in the web (see above).

Repair of shear cracks in the web of the structure illustrated in Fig. 7 was accomplished by adding vertical prestress

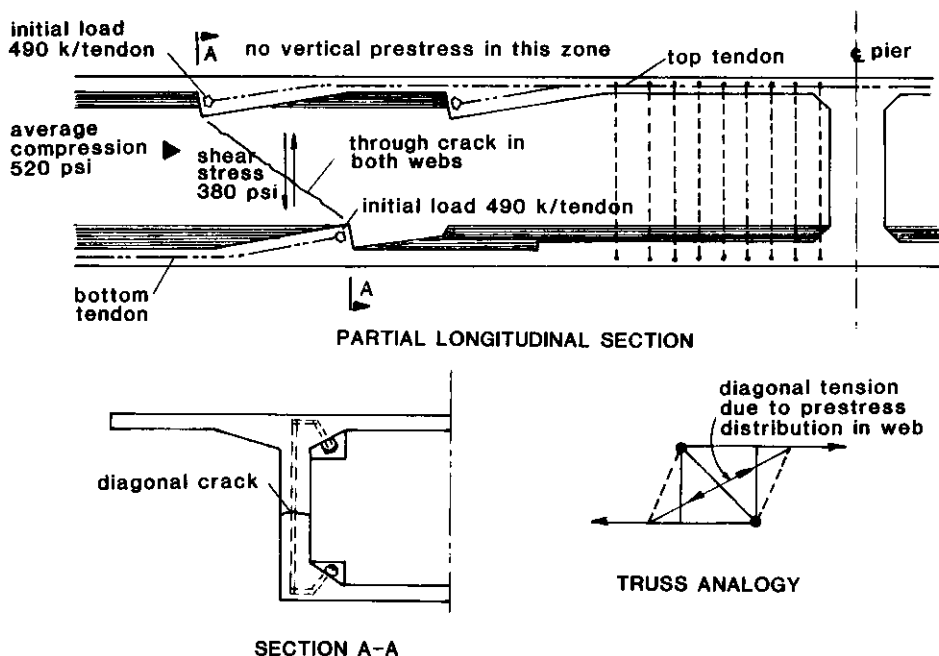
Fig. 32. Web cracking under high prestress force.

This situation occurred in a box girder constructed by incremental launching³ (Fig. 32). Permanent prestress was achieved by straight tendons placed in the top and bottom flanges, as required
