The Cause of Cracking in Post-Tensioned Concrete Box Girder Bridges and Retrofit Procedures

Walter Podolny, Jr.
Bridge Division
Office of Engineering
Federal Highway Administration
Washington, D.C.

This paper presents documentation of problems that have led to cracking in post-tensioned concrete box girder bridges in Europe as well as in the United States. It discusses cracking resulting from inadequate flexural and shear capacity, thermal stress cracking, and cracking resulting from tendon curvature and tendon misalignment. Also discussed are possible retrofit measures.

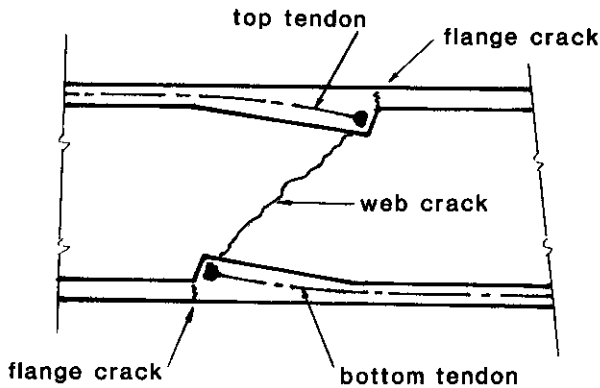
Fig. 30. Insufficient lap between anchorages.

2. Insufficient horizontal offset between tendon anchorages in the top and bottom flanges (Fig. 30).

If this type of cracking and/or failure is to be inhibited, the design, detailing, and placement of reinforcement in these highly stressed zones must be carefully considered. Location of blisters must be considered and there must be sufficient longitudinal reinforcement behind the blister or anchorage and sufficient transverse reinforcement abreast of the anchorage to accommodate the initial

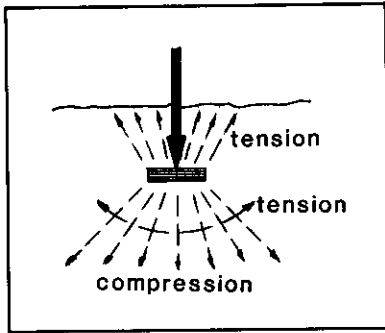
Fig. 33. Stress pattern at anchorage.

The cause of this type of cracking is the application of a tendon force to a small area of slab, in its plane, compressing the slab forward of the force in a zone of radial compression stresses that cause tensile stresses behind the point of application of the tendon force (Fig.

33).^{1,2} Among the parameters that can produce this type of cracking are the following:¹

1. Termination of numerous continuity tendons in a single section, particularly when the joint behind the anchorages is not compressed by other tendons and when passive longitudinal reinforcement does not traverse the joints between segments or is inadequate.

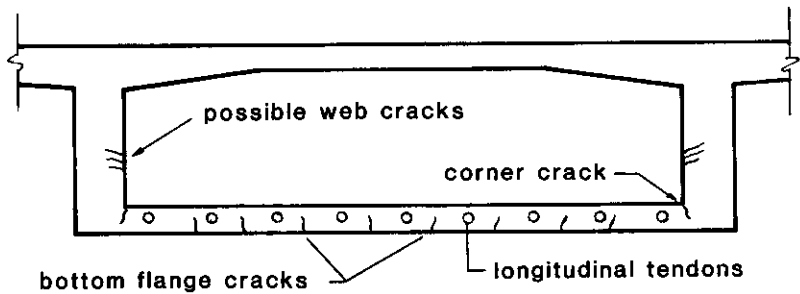
Fig. 34. Cracking from curved soffit tendons.

This type of distress is associated with variable depth girders and occurs in the positive moment area. It is manifested by longitudinal cracks occurring in the bottom flange, at the juncture of the bottom flange and web, and possibly in the web (Fig. 34).¹

At this stress level the tensile strength of the concrete would be exceeded, producing the longitudinal cracks depicted in Fig. 34.

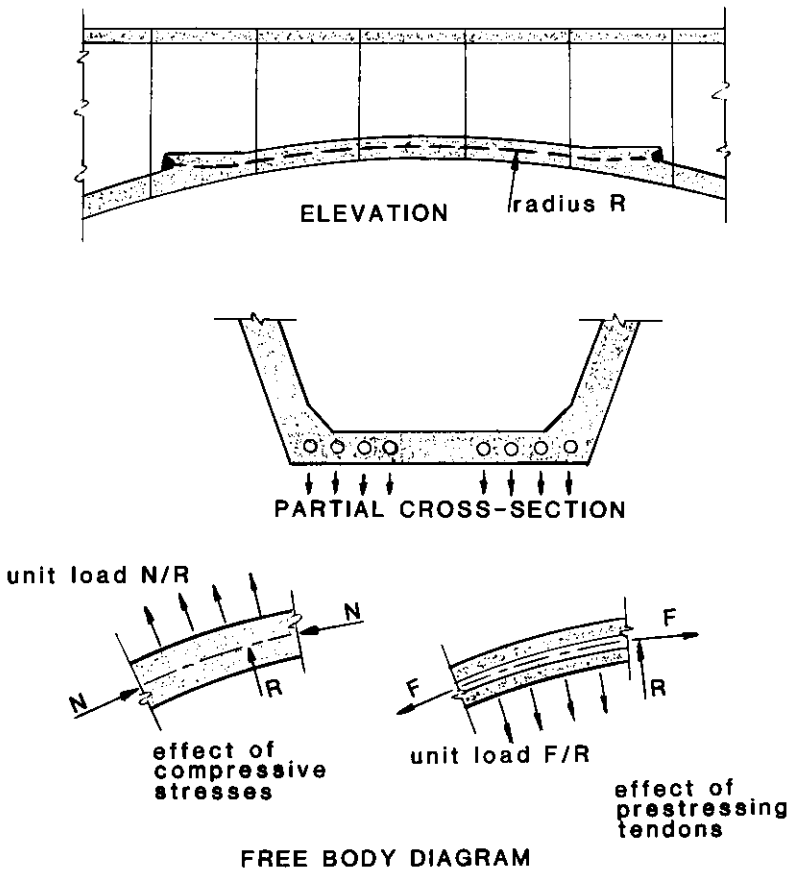
Fig. 35. Vertically curved tendon.

flange proper. When a variable depth girder is used, the bottom flange has a curvature in the vertical plane, which must be followed by the prestressing tendons (Fig. 35).

Unless careful consideration is given to that fact at the concept and detailed design stages, difficulties are likely to develop. This is indicated in Fig. 35, which shows the free-body diagrams of stresses in the bottom flange due to the curvature. Curvature of a tendon induces a downward radial force, which must be resisted by transverse bending of the bottom flange between the webs.³

Therefore, the effect of tendon curvature adds fully to the dead load stresses of the concrete flange. The corresponding flexural stresses may be four to five times greater than the effect due to dead load only, and if sufficient reinforcement is not provided for this effect, heavy cracking is to be expected and

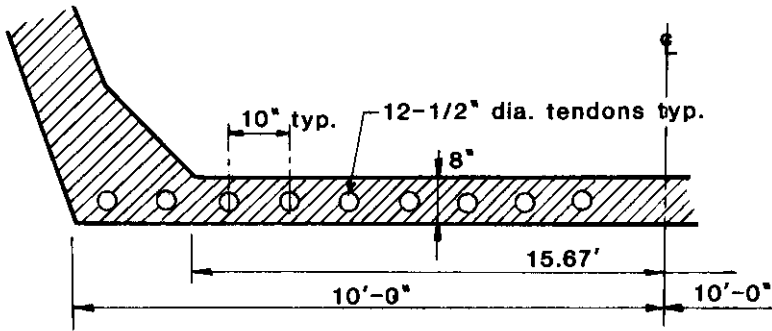
Fig. 36. Numerical example.

As a numerical example (Fig. 36) of secondary stresses due to vertically curved prestressing tendons, assume the following:³

$$f = M/S \\ = (9000)(12)/(12 \times 8^2/6) \\ = 840 \text{ psi (5.8 MN/m}^2\text{)}$$

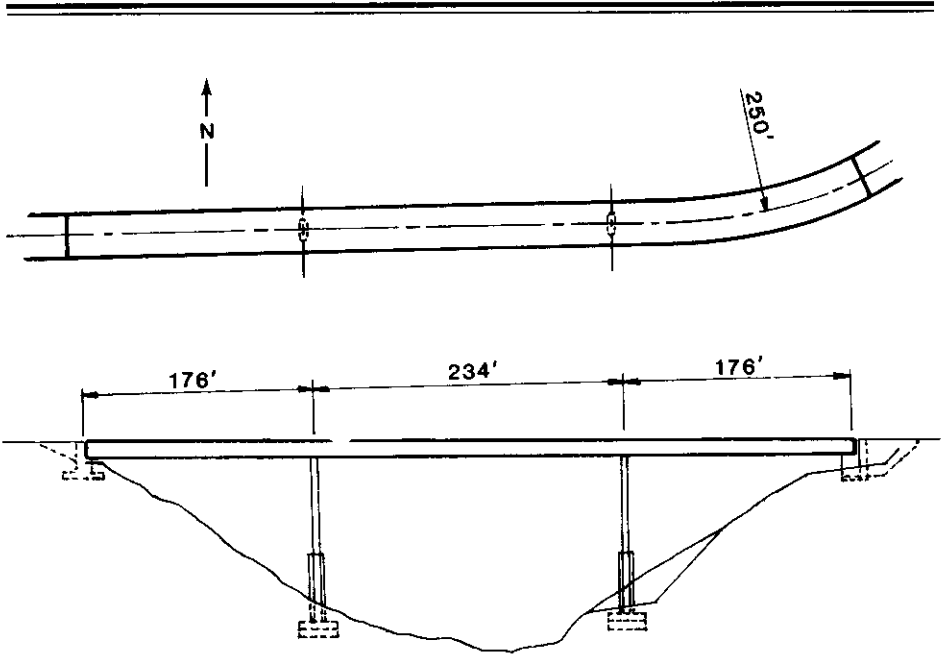
Fig. 37. Bridge elevation and plan.

The first example* is a continuous, cast-in-place, post-tensioned concrete box girder bridge, with three spans of 176, 234, and 176 ft (53.6, 71.3, and 53.6 m) with slightly over half of the eastern 176 ft (53.6 m) span aligned on a horizontal curve with a 250 ft (76 m) radius (Fig. 37). This 176 ft (53.6 m) curved span has three 12 in. (0.305 m) thick intermediate diaphragms, located at each quarter point of the span.

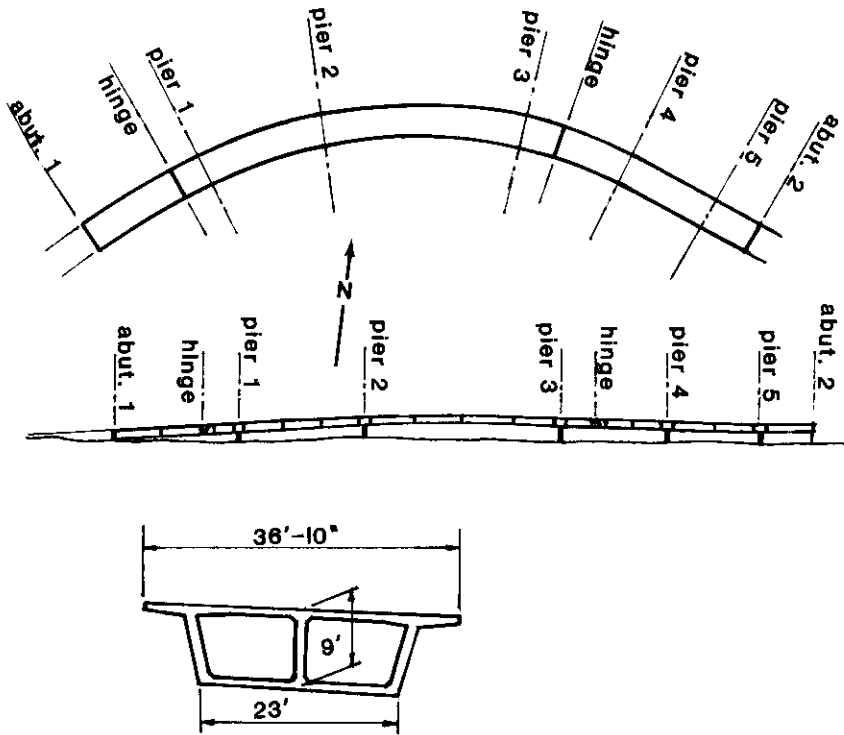
Fig. 42. Plan, elevation and section.

The second example* occurred on an interchange ramp (Fig. 42). This structure is a post-tensioned, cast-in-place, continuous, two-cell concrete box girder, constructed essentially on a curve with a radius of 540 ft (164.6 m). The structure, between expansion hinges, experienced concrete spalling and cracking during construction on the south web of the box along the curve as indicated in Figs. 43 and 44.

During the first post-tensioning operations, four tendons out of six in each web were fully post-tensioned, then noise was heard and cracking and spalling were observed along the south web.

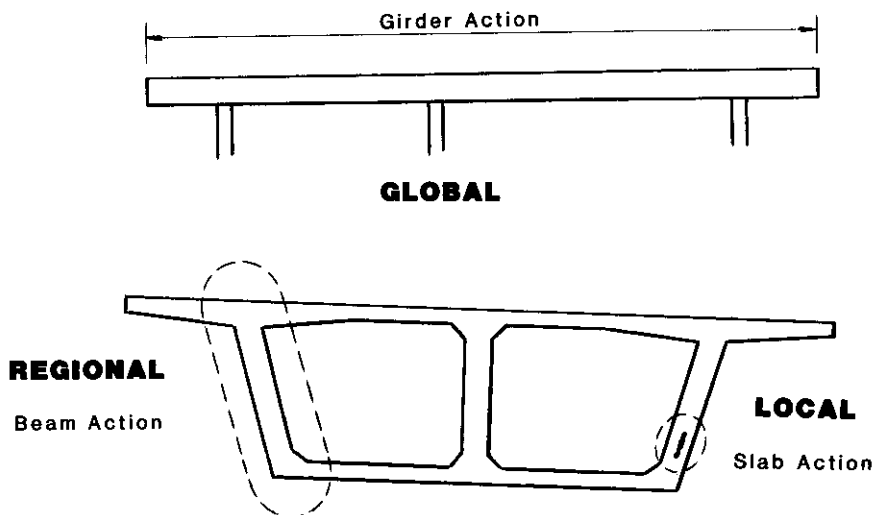
Fig. 45. Box girder actions due to horizontally curved tendons.

The analysis of the failure of these structures can be divided into three separate actions (Fig. 45) which need to be considered in design:

stresses are not a major factor. Thus, it is believed that the global action for both of these structures had only minor effects on the failures experienced, and were not quantitatively considered.

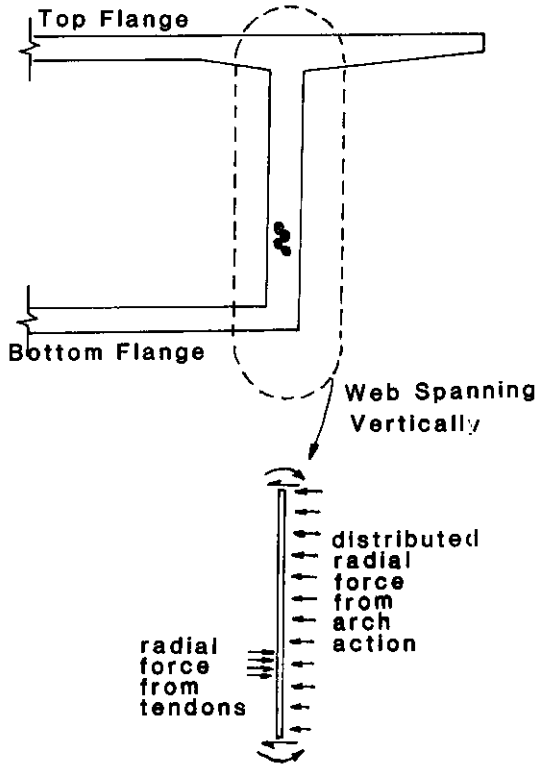
Fig. 46. Vertical span of web.

Regional action considers each web as a beam supported at the top and bottom flanges. This beam (Fig. 46) is acted upon by the radial force from the tendons. The radial tendon force produces shear and bending in the web, as it spans vertically. The bending moment and shear in the web are also influenced by the fact that the web concrete is under longitudinal compression from tendon prestress.

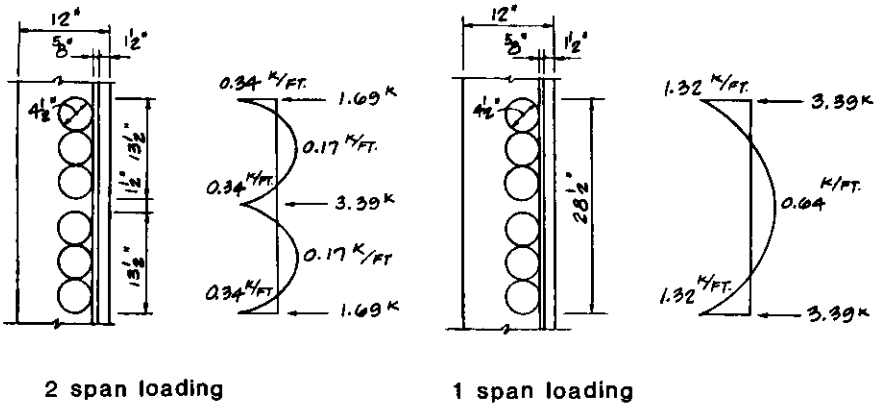
Fig. 48. Slab action.

Local slab action is probably the most important item that actually caused the failure in both of these structures. The local slab action can be studied in different ways. First, consider the cover as a slab 2 in. (50 mm) thick (reinforced with #5 bars along the inside face only) acting as a two-span continuous beam with a central support furnished by the concrete between the two sets of bundled tendons, as shown on the left of Fig. 48.

The second analysis, shown to the right in Fig. 48, assumes that the concrete has cracked and is unable to supply tension for the support area between the bundled tendons. If this is the case, the slab will act as a single span fixed at the ends; however, the reinforcement is in one plane on the inside face only. This can offer very little resistance to the radial force from the tendons, both in bending and in shear. The stresses are exceedingly high.

An extraordinarily high percentage of reinforcing steel would be required to resist such moments. Unfortunately, the tendons were tied to the stirrups on the inside of the curvature; thus the stirrup reinforcement is in position next to the tendon ducts such that it does not function to resist positive moment produced by the radial forces. Therefore, the concrete cover essentially is a plain concrete slab and its resistance is nil.

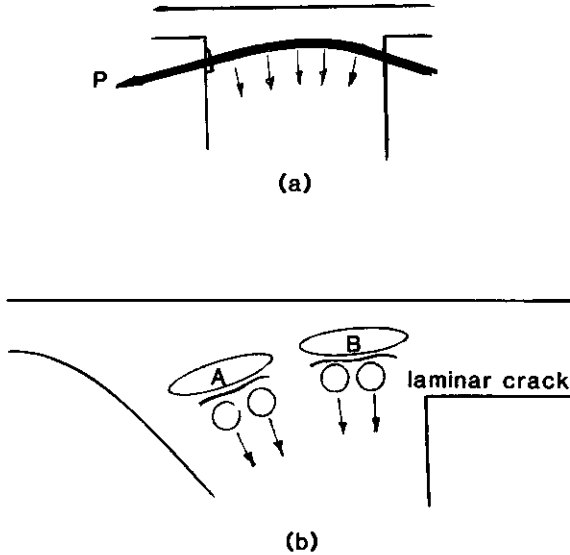
Fig. 55. Diaphragm cracking from tendon curvature.

54. The external tendons pass through the diaphragm along a vertically curved profile and are anchored in the diaphragm face which produces a radial pressure as indicated in Fig. 55a. As a result, a tensile stress field is set-up above the tendons (Fig. 55b) similar to the tension stress field behind an anchorage blister. This tension field may then cause a laminar crack above the tendons.

In addition, a splitting crack may develop as a result of multi-strand compaction in the zone of curvature as discussed above. It appears that the laminar crack either by itself or in conjunction with the splitting crack, over a period of time will propagate to the surface and produce spalling. Spalled areas of the deck have been as large as 3 x 3 ft (1 x 1 m). The spalled surface in two projects were located generally over the

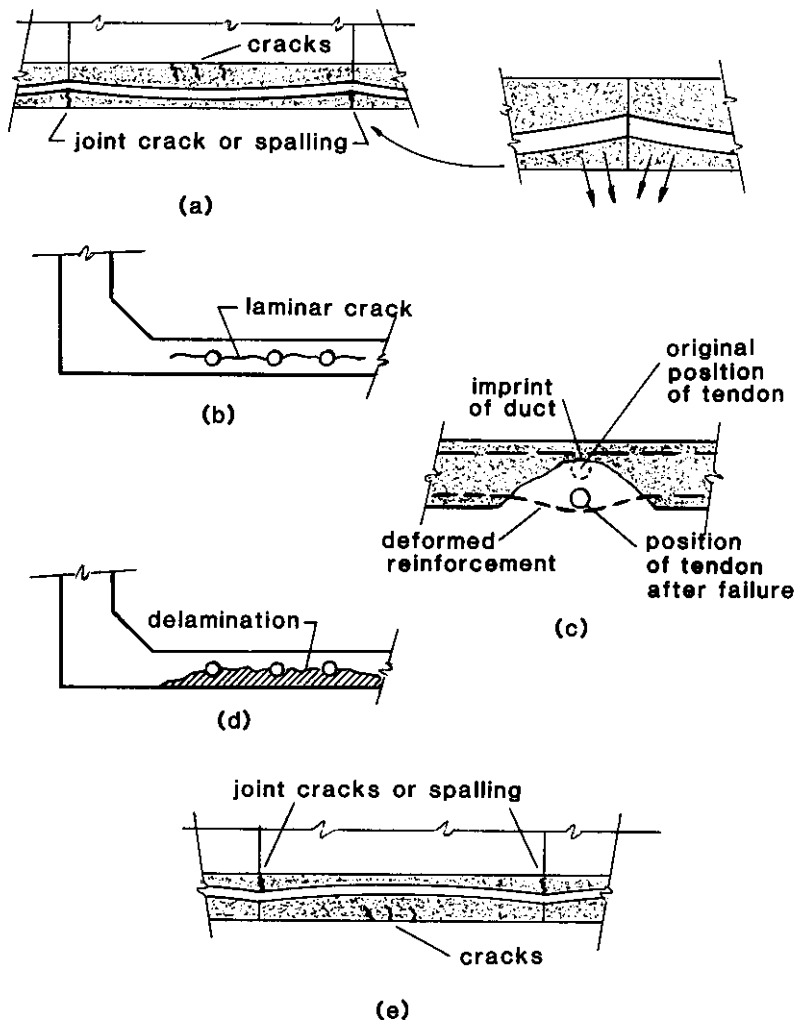
Fig. 57. Effects of misalignment of tendon ducts.

Laminar cracking may then propagate to a spalling failure during further tensioning of the tendon (Fig. 57c) which will produce a deformation in the reinforcing steel and displacement of the tendon. In some instances, spalling has occurred during water pressurization tests or during grouting, especially when all tendons in a group are tested or grouted simultaneously (Fig. 57d).

Occasionally, because of the wrong height chairs or mislocation, the profile will be inadvertently placed in an inverted profile as shown in Fig. 57e. Obviously, the cracking and/or spalling pattern will be inverted from that shown in Fig. 57a.

This problem can be avoided by the use of rigid ducts properly positioned and securely tied to the reinforcing cage, use of a rigid mandrel placed inside of the duct during casting, and providing work bridges for workmen so that they do not walk in the wet concrete.

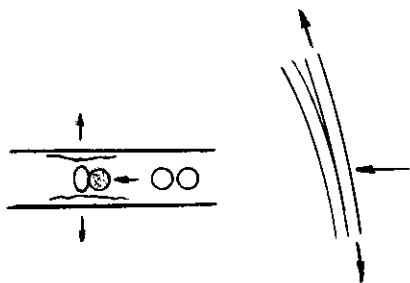
Fig. 58. Lateral duct crushing.

problem indicated that during construction the longitudinal tendons had been deflected downward because of an interference with the deflected profile of the transverse tendons.

The result of the upward components of the two curved tendon systems probably created a laminar crack upon tensioning of the tendons. Air pressure used to blow out the remaining unstressed tendon ducts probably propa-

gated the laminar crack initiated during stressing and precipitated the spalling. A factor closely associated with this failure was the numerous closely spaced longitudinal ducts.

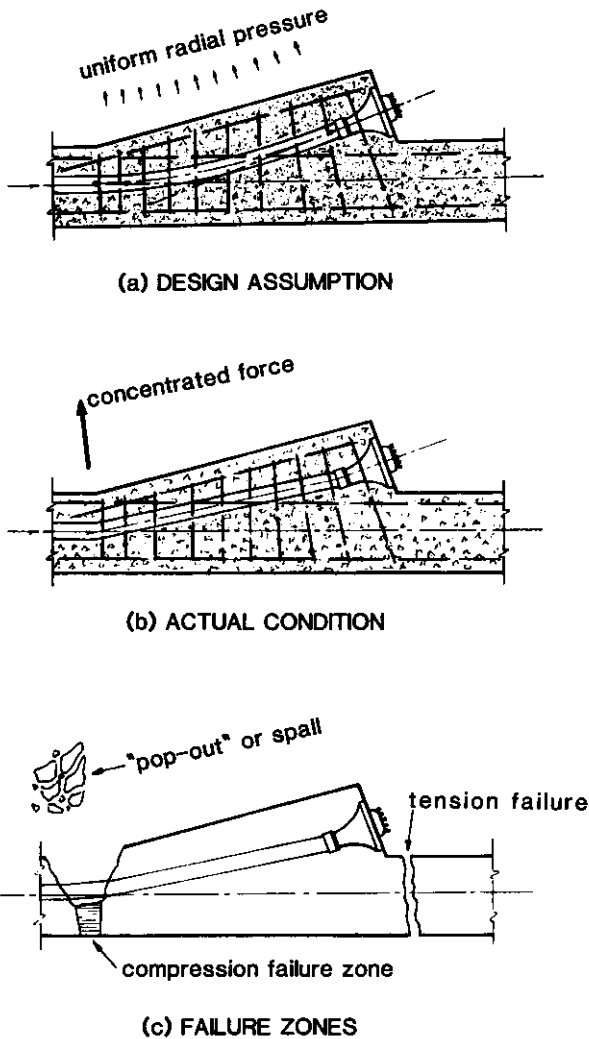
Fig. 59. Anchorage blister failure.

Another form of cracking, spalling and failure is associated with misplacement of a curved tendon in a blister anchorage. The design assumes that the tendon profile as it leaves the flange (or web) and enters the anchorage blister is a smooth curve (Fig. 59a) with a uniform pressure along the curve. In reality, this is seldom accomplished in construction. The duct usually has an angular "kink" instead of a smooth curve transition, which produces a concentrated force at the toe of the blister (Fig. 59b).

This then leads to a spalling or "pop-out" failure (Fig. 59c). The concrete area in the slab forward of the blister is then reduced, leading to a compression fail-

ure at that location, tension failure behind the blister and shearing along the longitudinal sides of the blister.

sile forces behind the blister, and adequate transverse reinforcement should be used to cater to shear forces alongside of the blister.

The design of blisters requires, in addition to reinforcement for anchorage bursting stresses, adequate reinforcement for shear and bending between the blister and the flange or web interface. Consideration should be given to Sections 11.7 and 11.9 of the ACI Building
